NM 14/NM 536/Frost Rd Intersection Reconstruction CN A301442

TransCon 2023

AGENDA

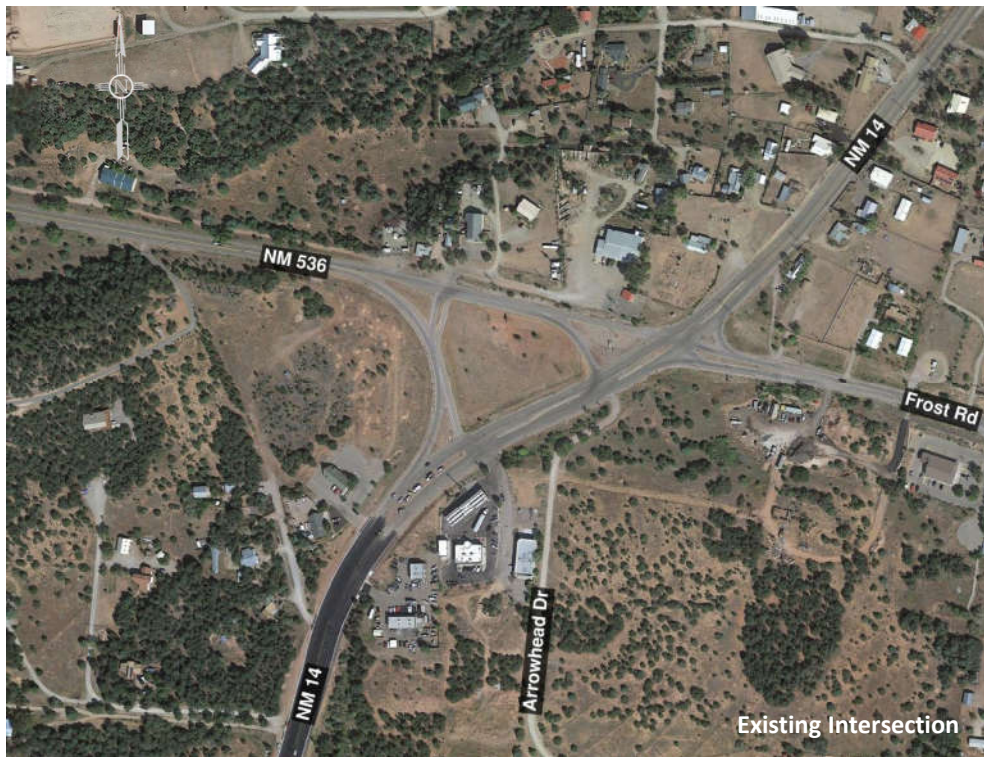
Phase 1A/B Study Completed Spring 2018

Purpose of the study was to:

- Reduce congestion
- Improve driver expectation
- Improve access spacing
- Consider multi-modal opportunities

6 intersection alternatives were evaluated

- No Build
- Split Intersection
- Split Intersection with High-T
- South Realignment
- North Realignment
- Roundabout

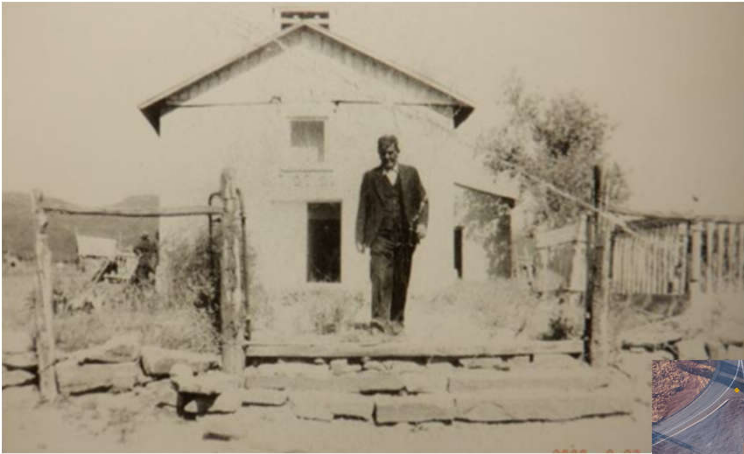
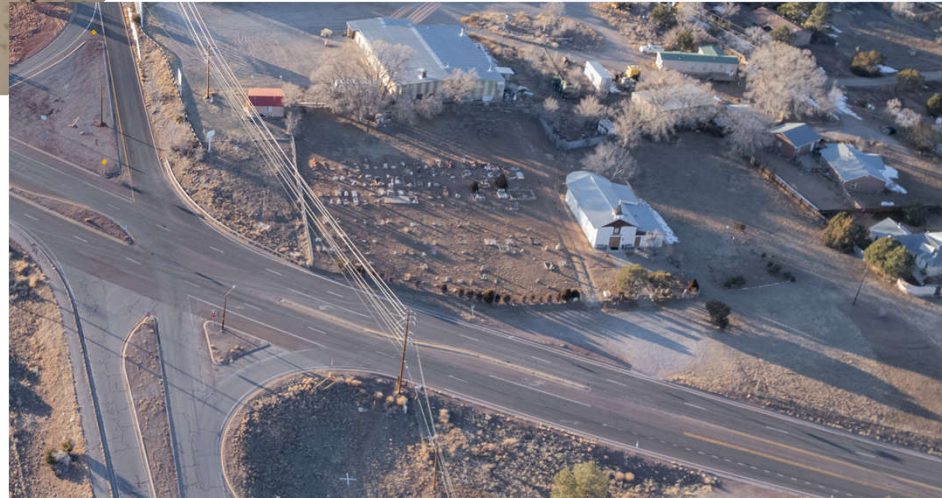
San Antonito Church and Cemetery

- Church was built in 1886
- Earliest dated grave marker is dated 1895
- Corner of cemetery is 5ft from NM 14 pavement
- Satisfies NRHP Criterion A (historical and cultural significance) and Criterion C (distinctive architecture)

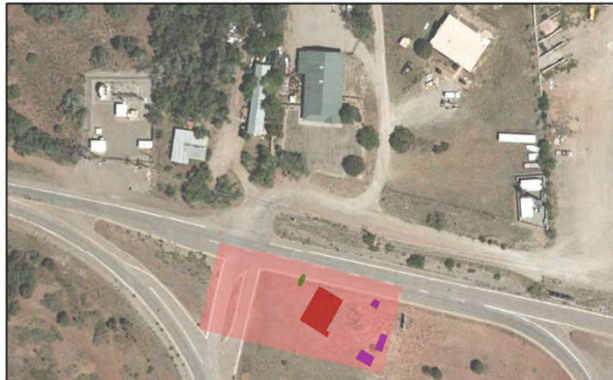
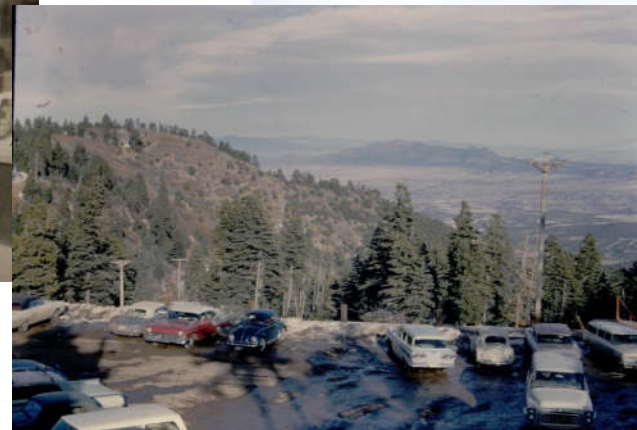
Figure 2a
Site Plan
Preliminary Site Investigation
(CN: A301442) NM14/NM 536 Intersection
Bernalillo County, New Mexico

- Because history of underground storage tanks (UST's) was unknown, HMIB conducted a Preliminary Site Investigation (PSI)
- Included geophysical survey to locate relic UST's and 13 soil borings to identify potential contaminants
- No evidence of UST's or soil contamination was found

- Legend
- Historical Gas Pump
 - Historical Service Station
 - Historical Shed
 - Geophysical Survey Extent

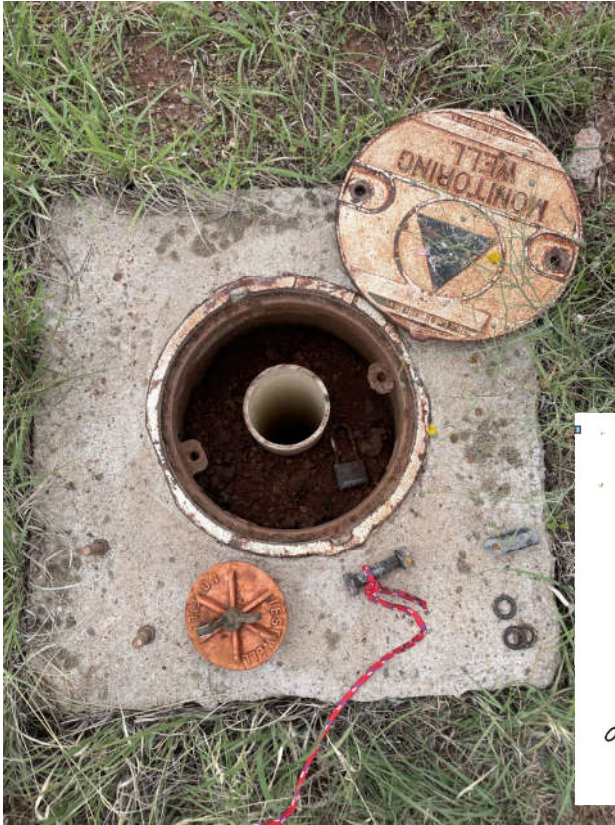
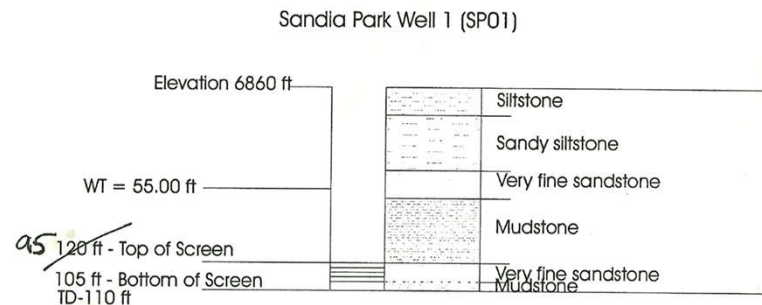
Monitoring Well

- Well installed as part of a nitrate study conducted by Bruce Thomson (UNM)
- As water levels decreased, it was assumed the well went dry but needed confirmation
- Used rope, an old bolt, and sidewalk chalk to verify bottom of well was dry

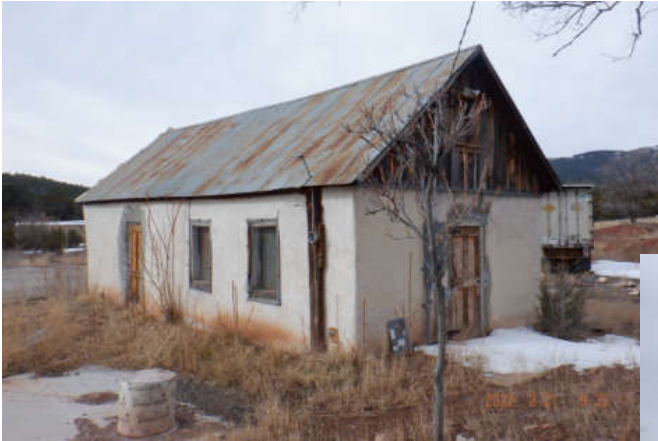
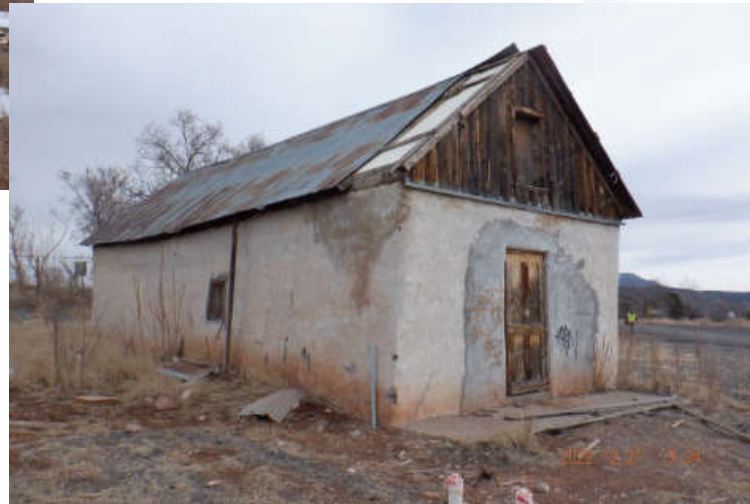
Old Spanish Store (1920s – 1950s)

- Newspapers affixed to the interior walls date back from early 1920s to 1954 (around the time Frost Road alignment was moved)
- Satisfies NRHP Criterion C (likely to produce additional important information concerning the early twentieth century history in Bernalillo County)

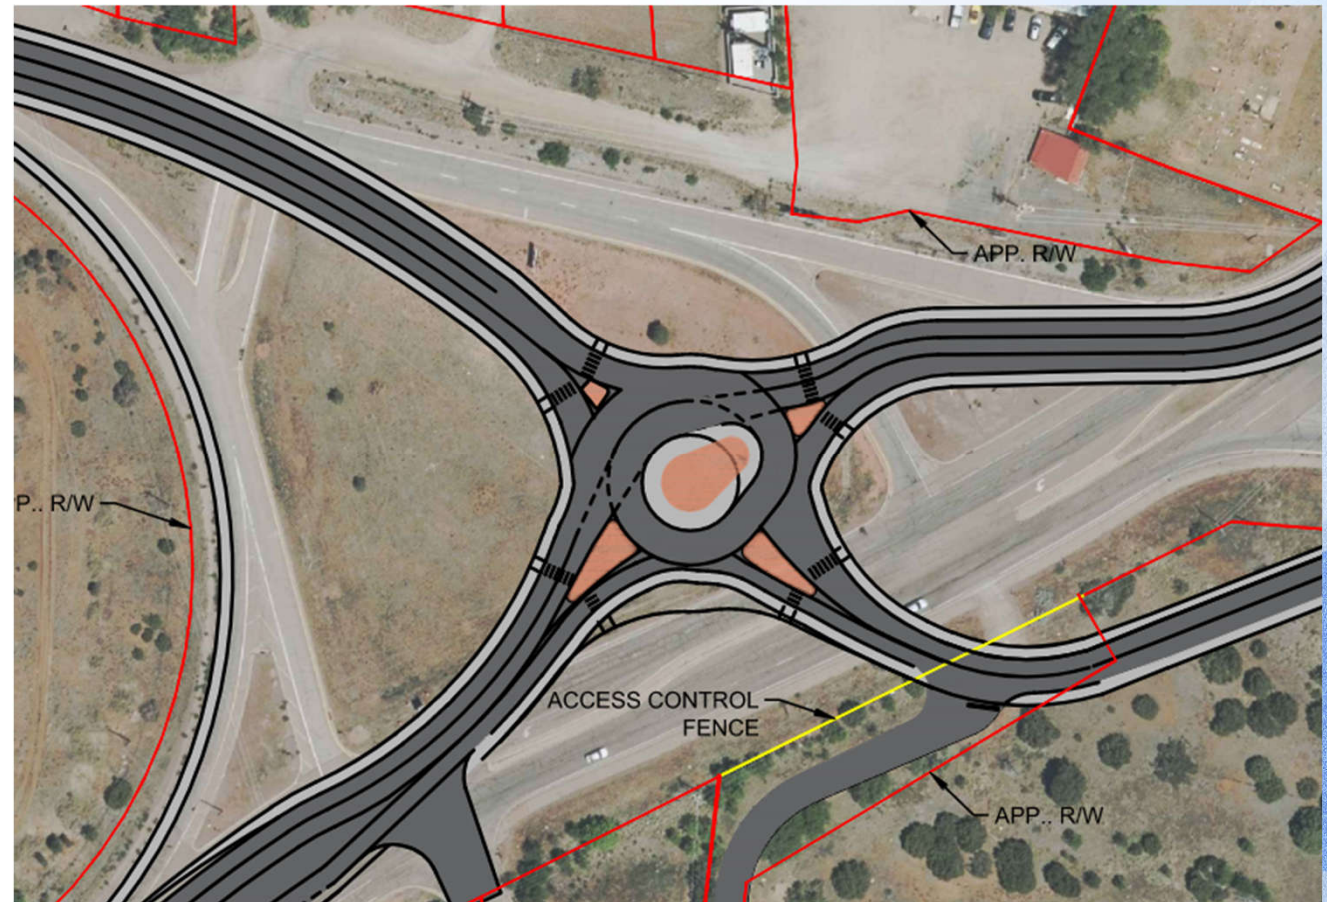
Previous Iterations

- Did not provide good lane separation.
- Very early design, but similar layout to final configuration.
- Constructability could be further improved.

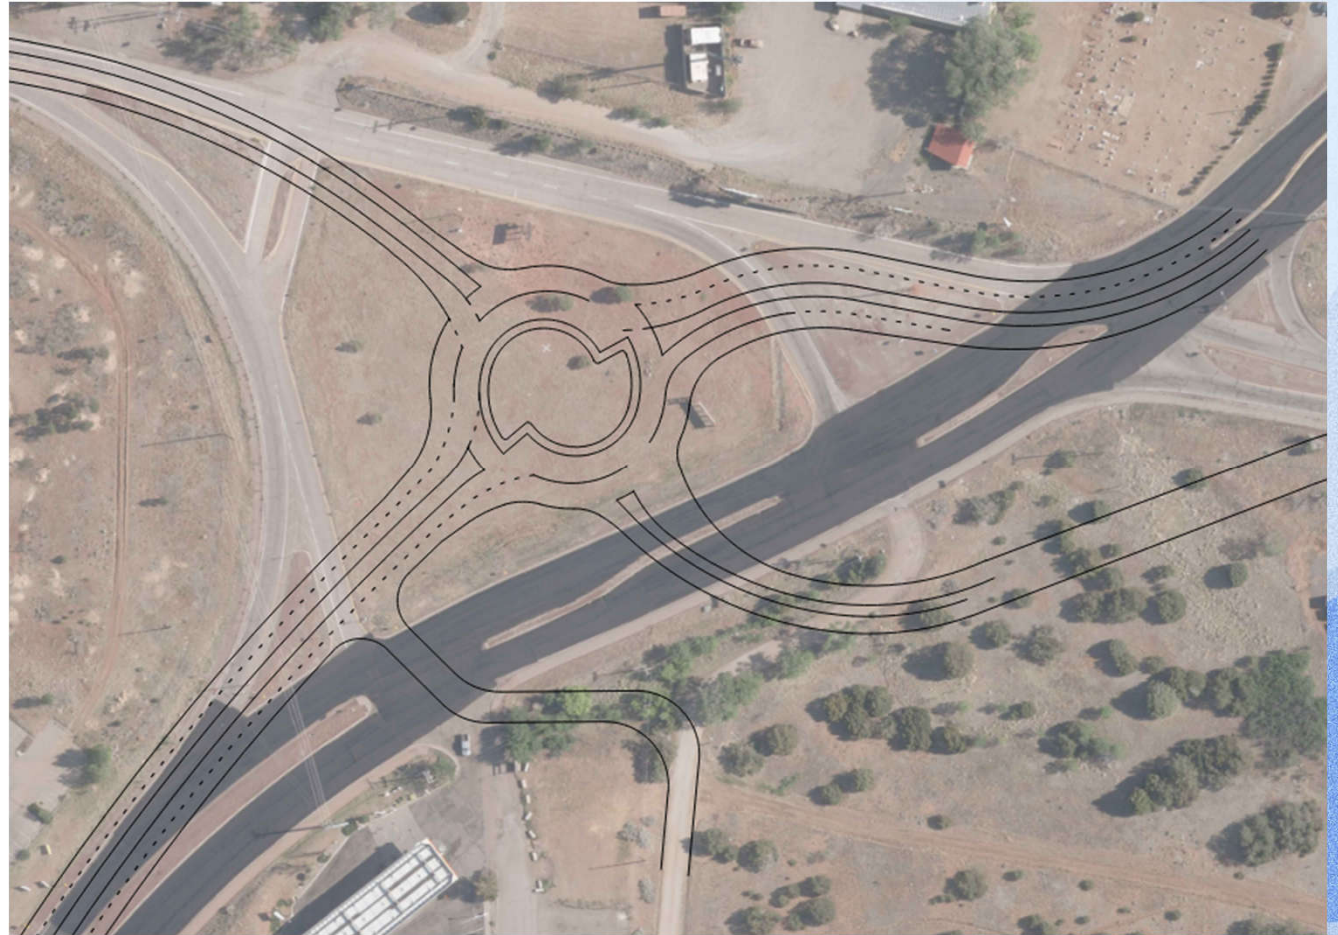
Previous Iterations

- Additional capacity for NM 14 traffic.
- Proposed to use additional turbo roundabout elements.
- Extra capacity was not necessary.

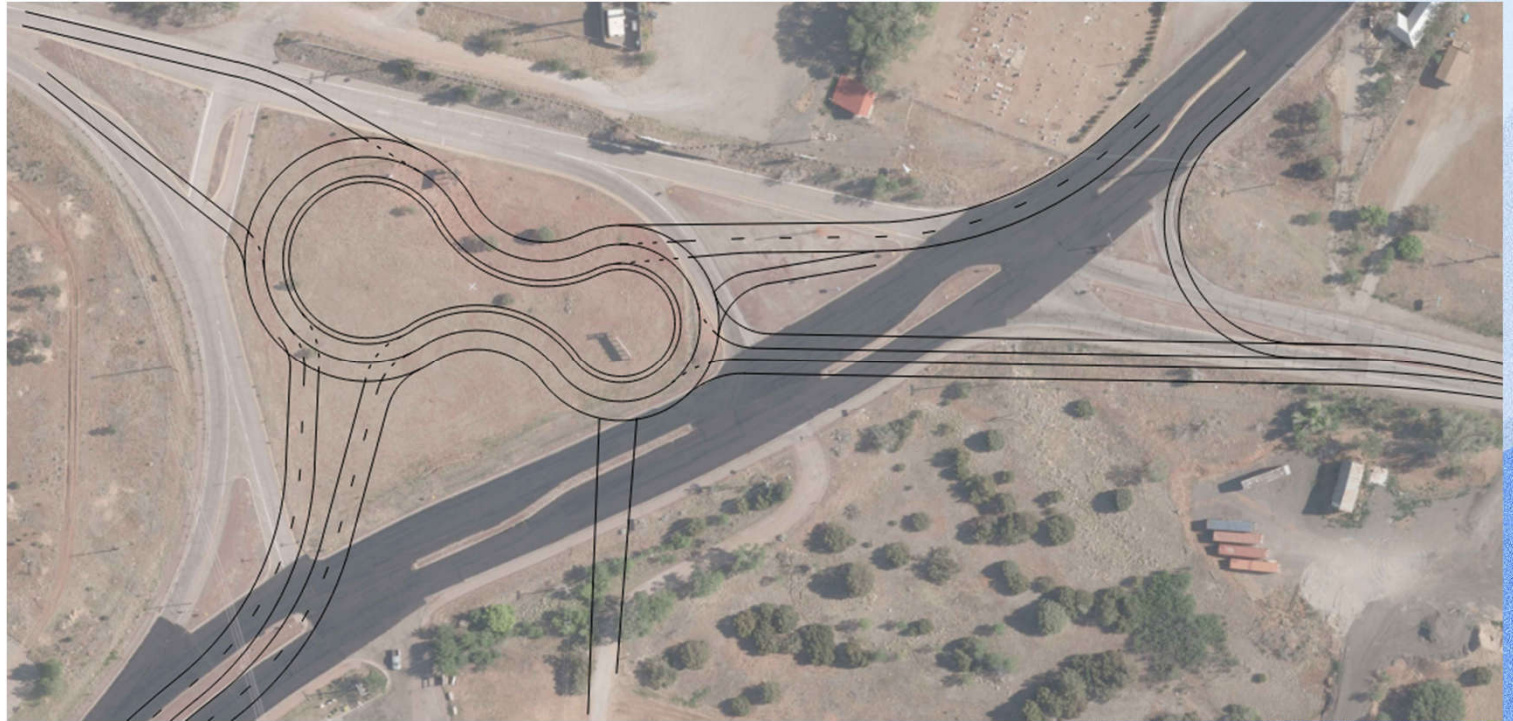
Previous Iterations

- A peanut-about provided very favorable horizontal geometry.
- The larger footprint made vertical design much more difficult.
- Created a large amount of out-of-direction travel.

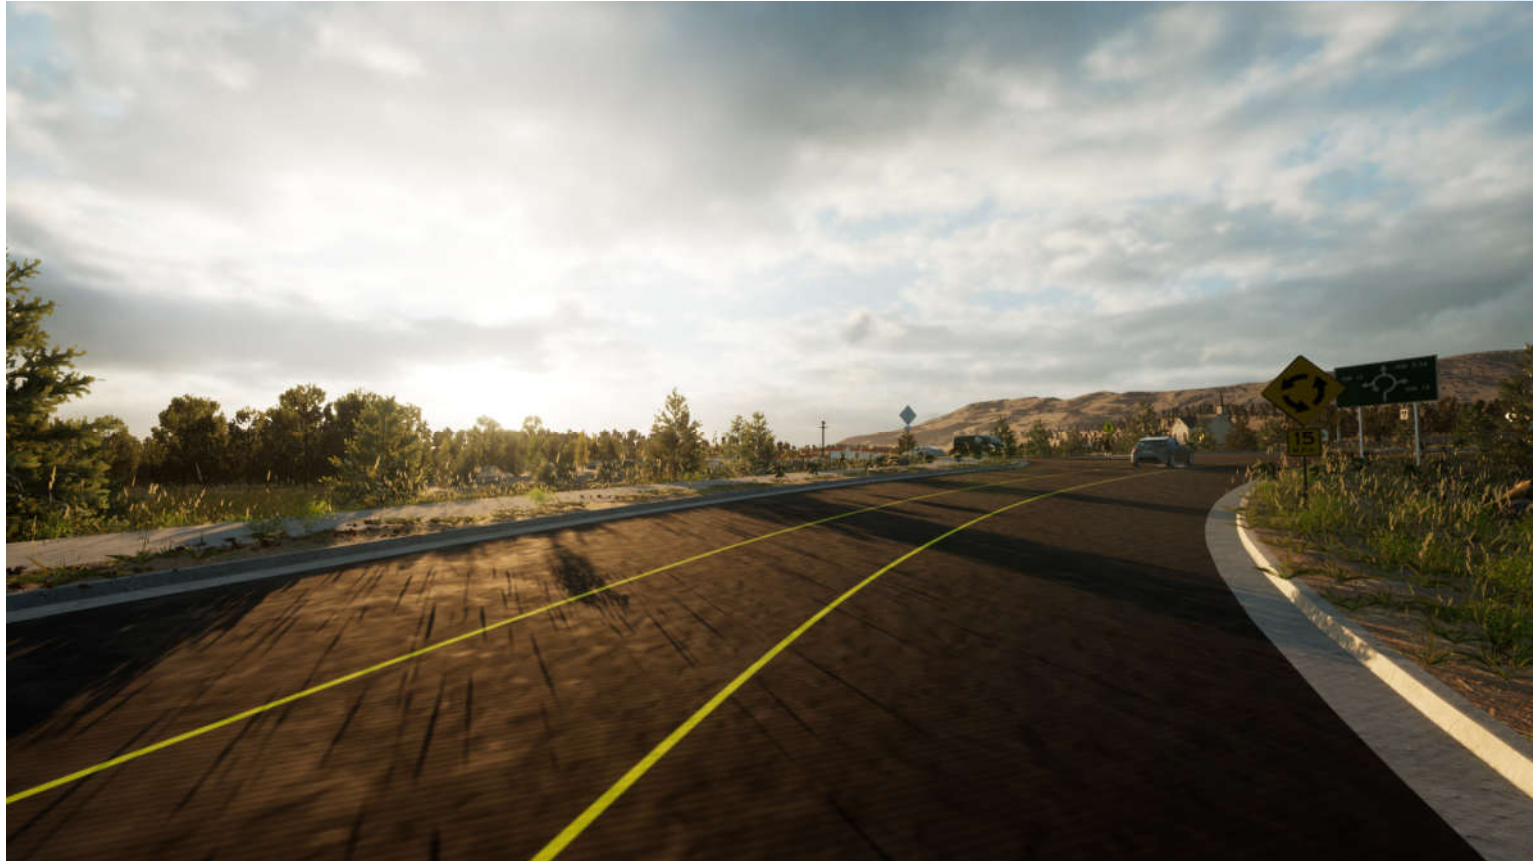
Approach to Geometry

- Use geometry to lower travel speeds on the approach to the roundabout.
- Accomplished by incrementally reducing the horizontal and vertical design speed.
- Supplemented by permanent signing.
- Intersection lighting will provide additional emphasis overnight.

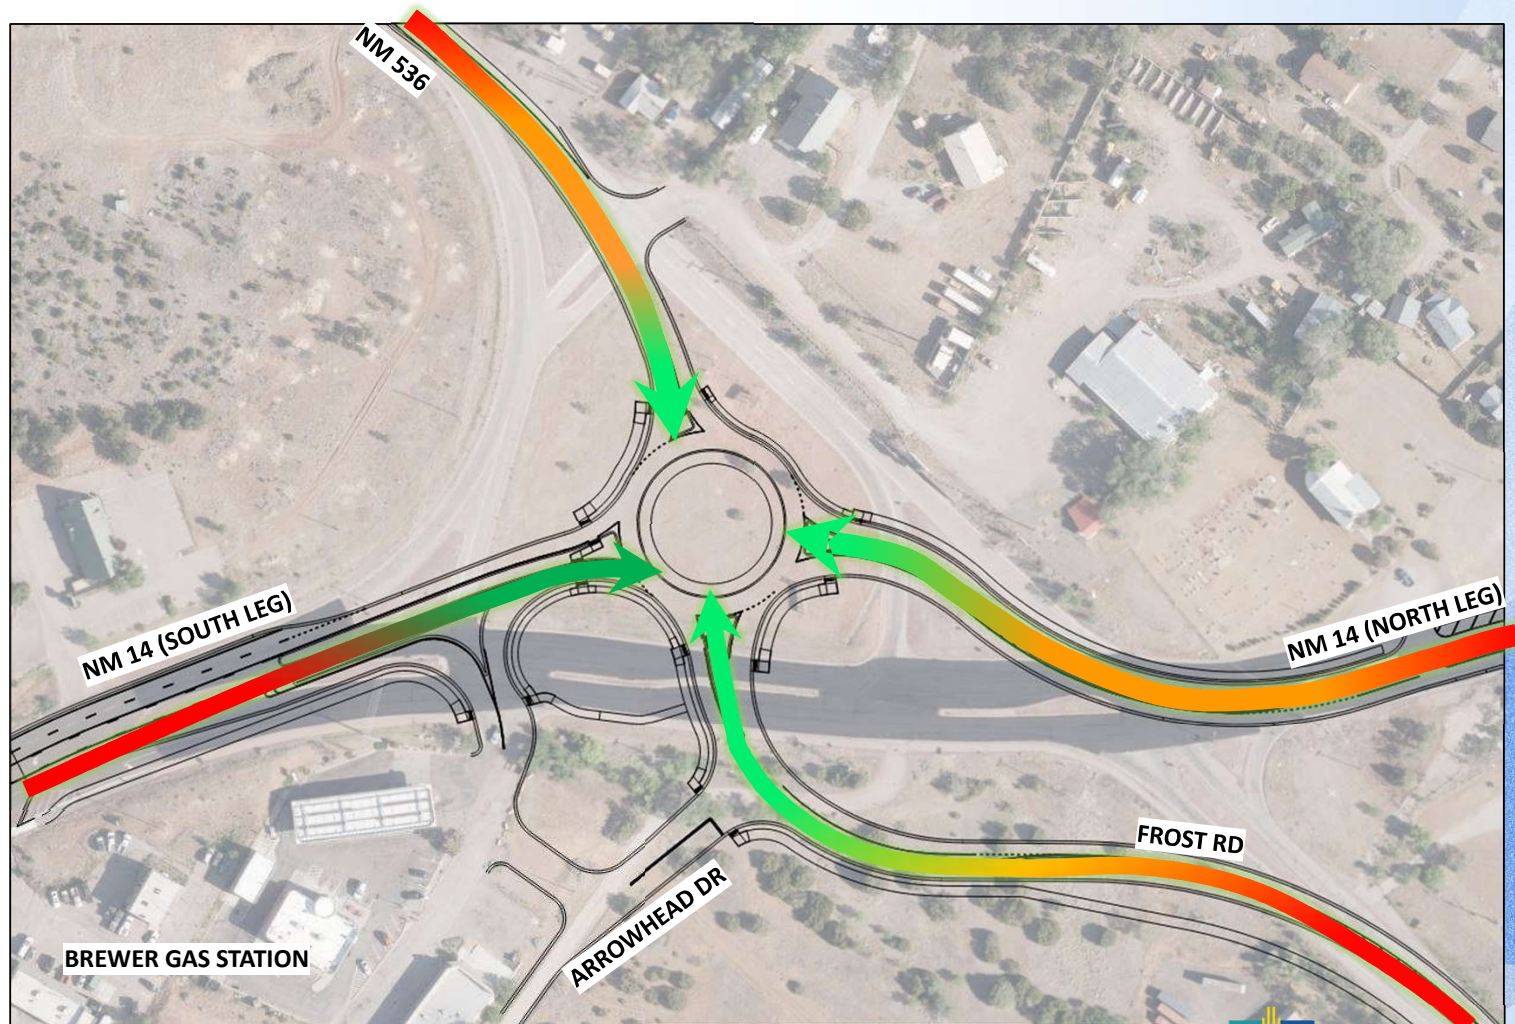
Horizontal Alignment

- Inscribed circle diameter of 180 feet.
- Accommodates a WB-67 design vehicle.
- High degree of deflection for through movements.
- Splitter islands are mountable, providing additional comfort for large vehicles.
- School busses and emergency vehicles can navigate without the use of the truck apron.

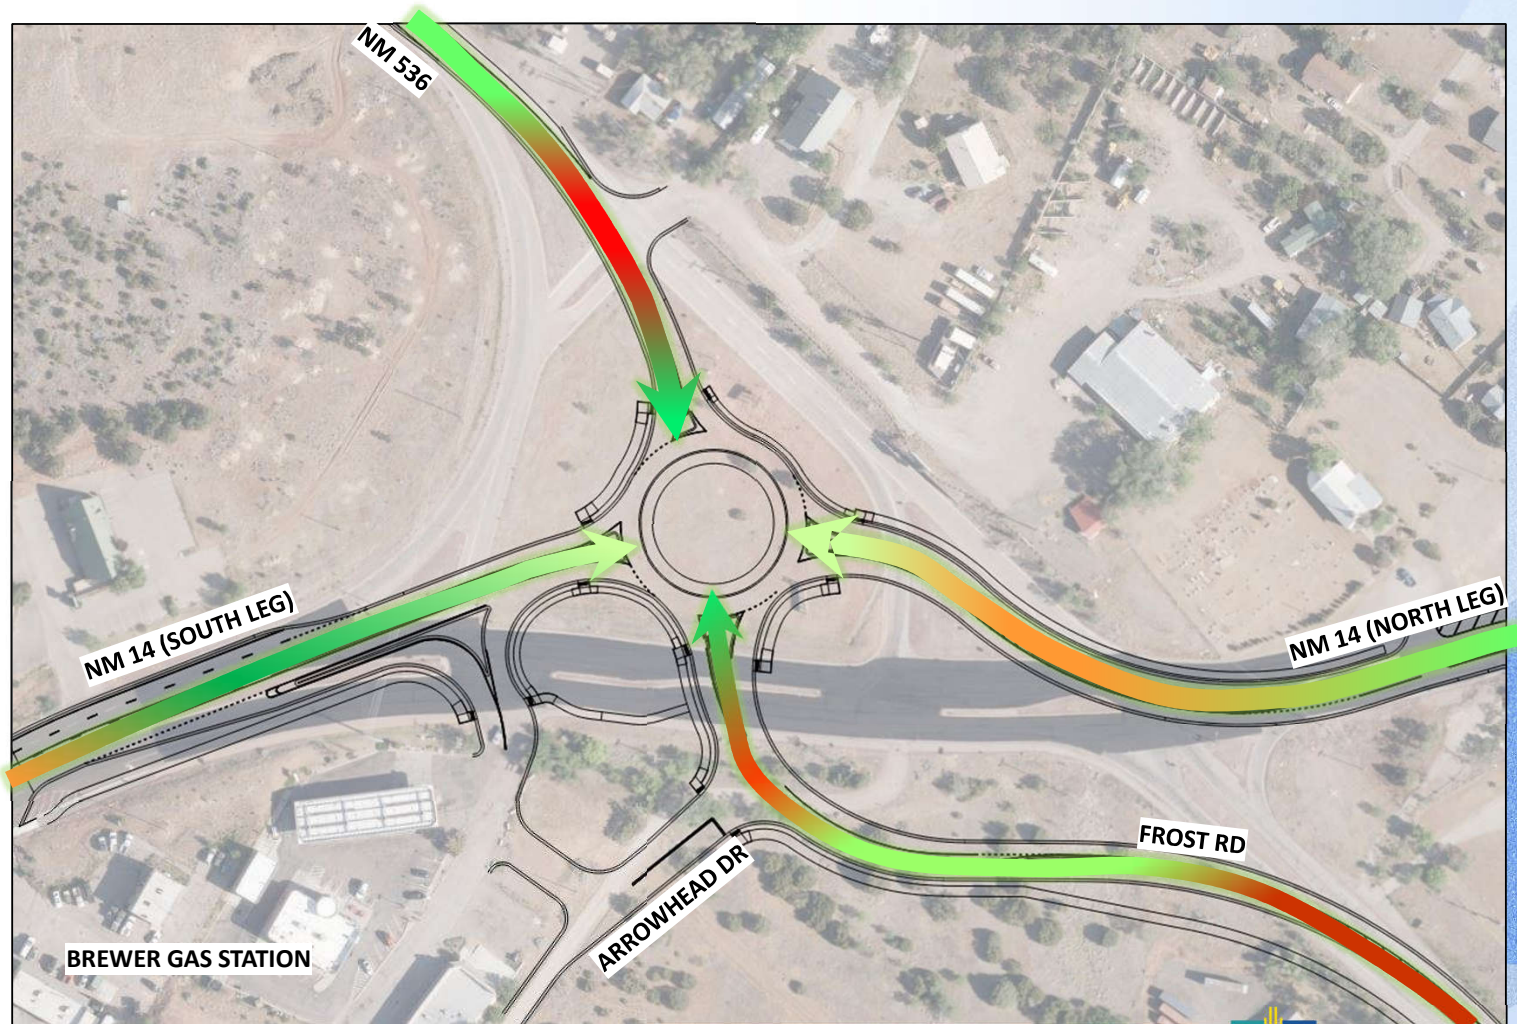
Vertical Profile

- Total elevation change of 65 feet.
- The maximum grade falls along NM 536 at 6.5%
- Frost Rd ties back at an existing 5.2%
- NM 14's north leg has a maximum grade of 6.0%
- NM 14's south leg is generally less than 1.5% within the reconstructed areas.

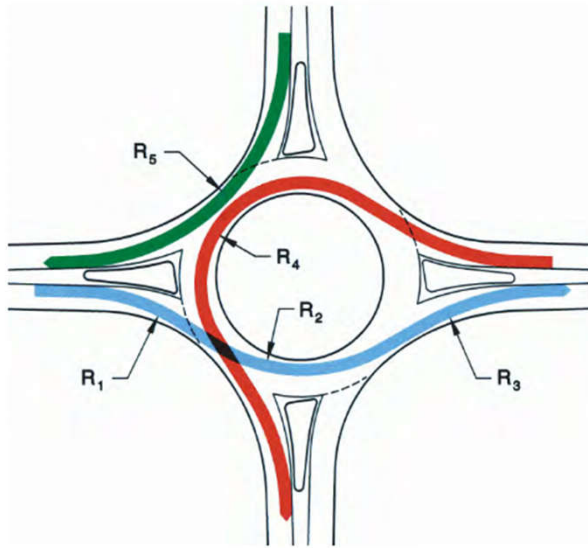
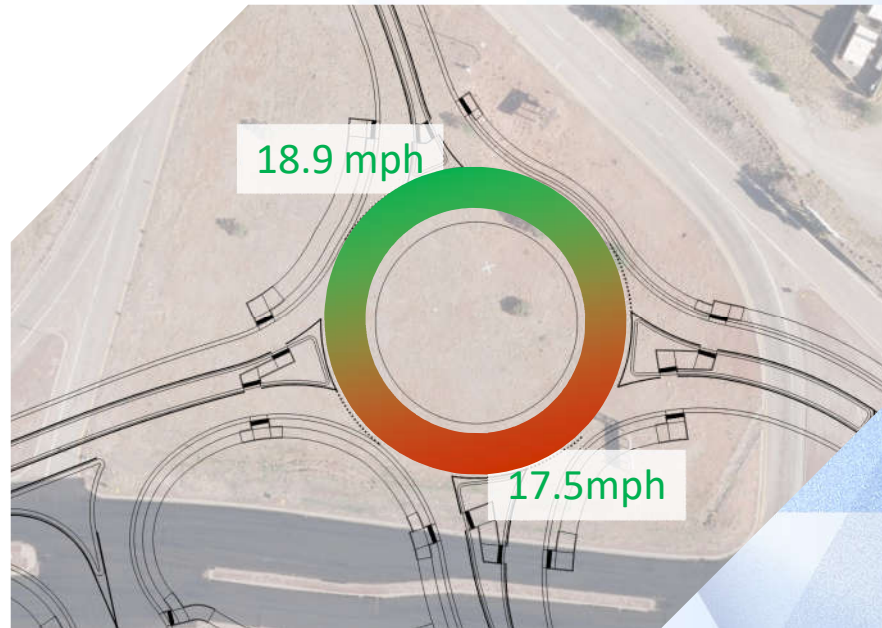
Fast Path Analysis

- Maximum speed different is just under 10mph.
- Average speed is 20.5mph.

Fast Path ID	NM 536		NM 14(North)		Frost Rd		NM 14(South)	
	Radius (ft)	Velocity (mph)	Radius (ft)	Velocity (mph)	Radius (ft)	Velocity (mph)	Radius (ft)	Velocity (mph)
R1/V1	138	23.13	182	24.13	144	23.66	105	21.33
R2/V2	76	18.12	76	18.77	76	18.1	77	17.58
R3/V3	189	26.47	156	22.69	145	23	141	23.76
R4/V4	63	16.62	75	18.76	77	18.4	75	17.36
R5/V5	104	19.55	109	20.59	67	17.76	89	19.7

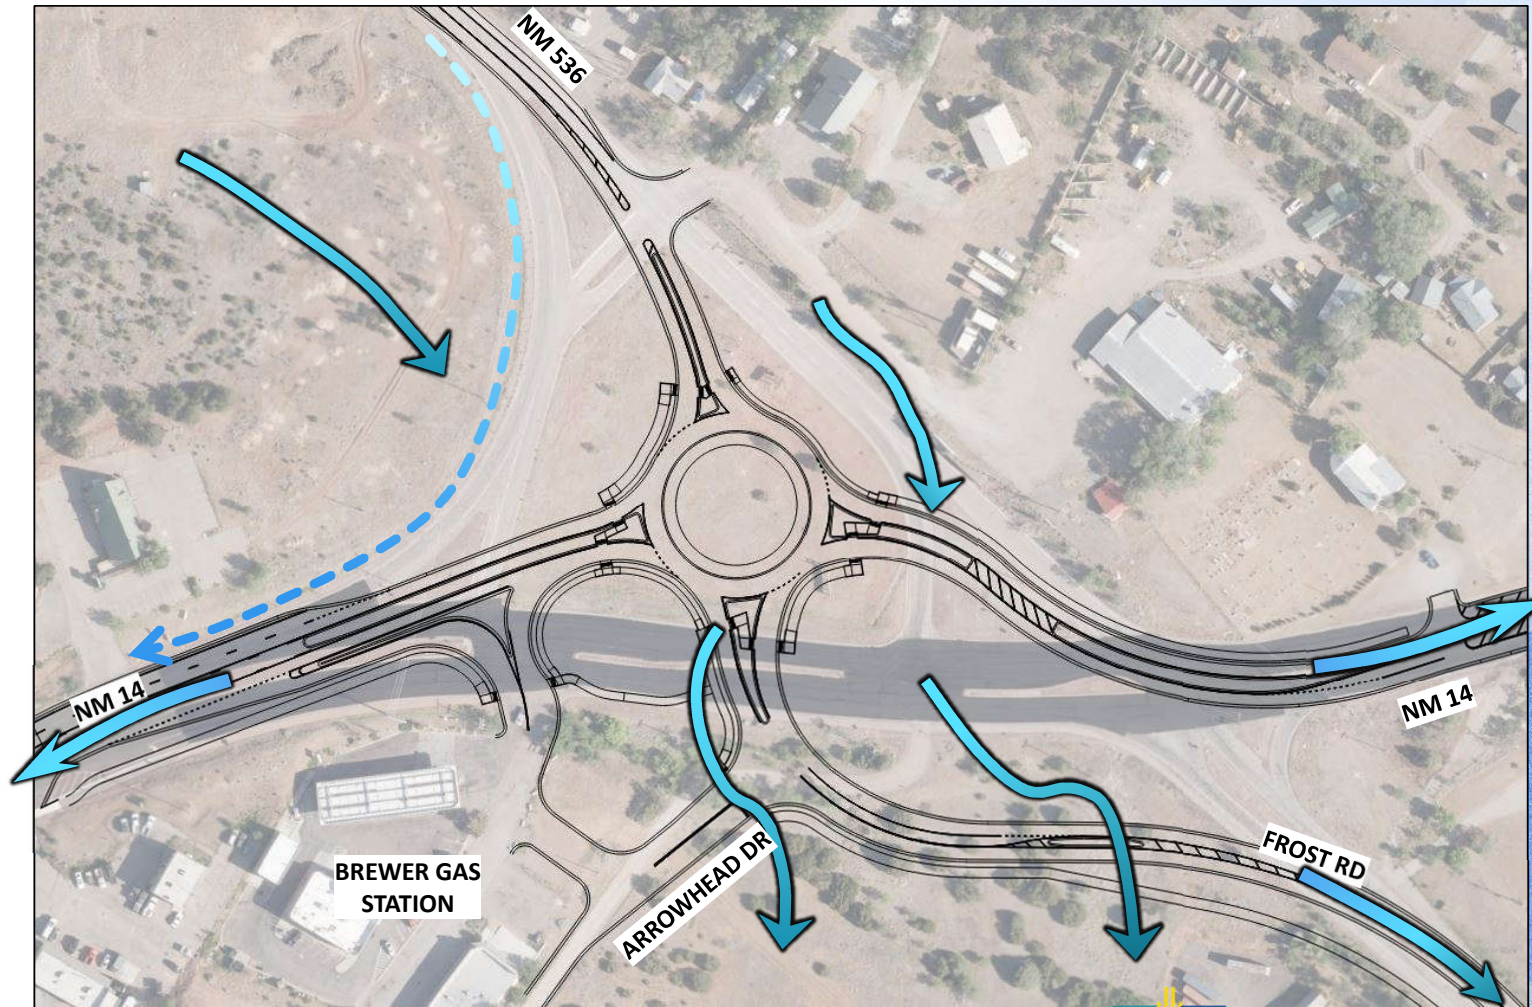
Proposed Conditions

- Existing storm drain infrastructure will be removed as it will no longer serve the proposed design
- Existing flows are maintained beyond project limits
- Roadway drainage is accommodated with storm drains.

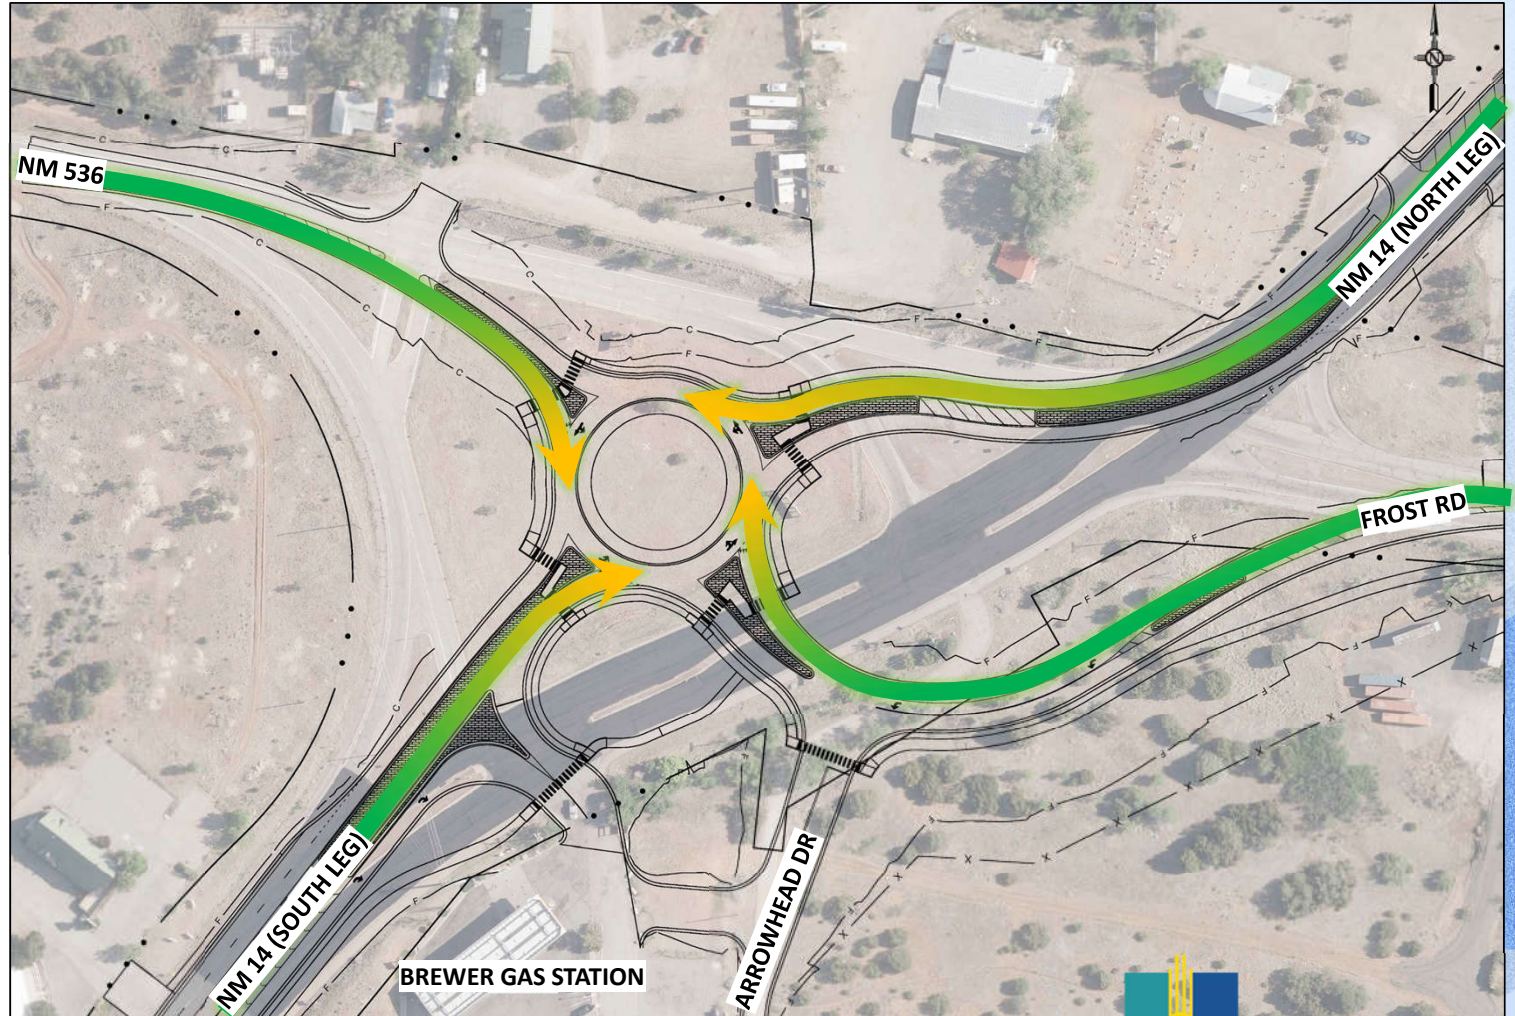
Proposed Layout

- Consolidated intersection
- Single lane approaches
- Maintain existing driveways
- Arrowhead now connects to Frost Road
- Accommodates WB-67 with apron and S-Bus-40 without apron (including emergency response vehicles)

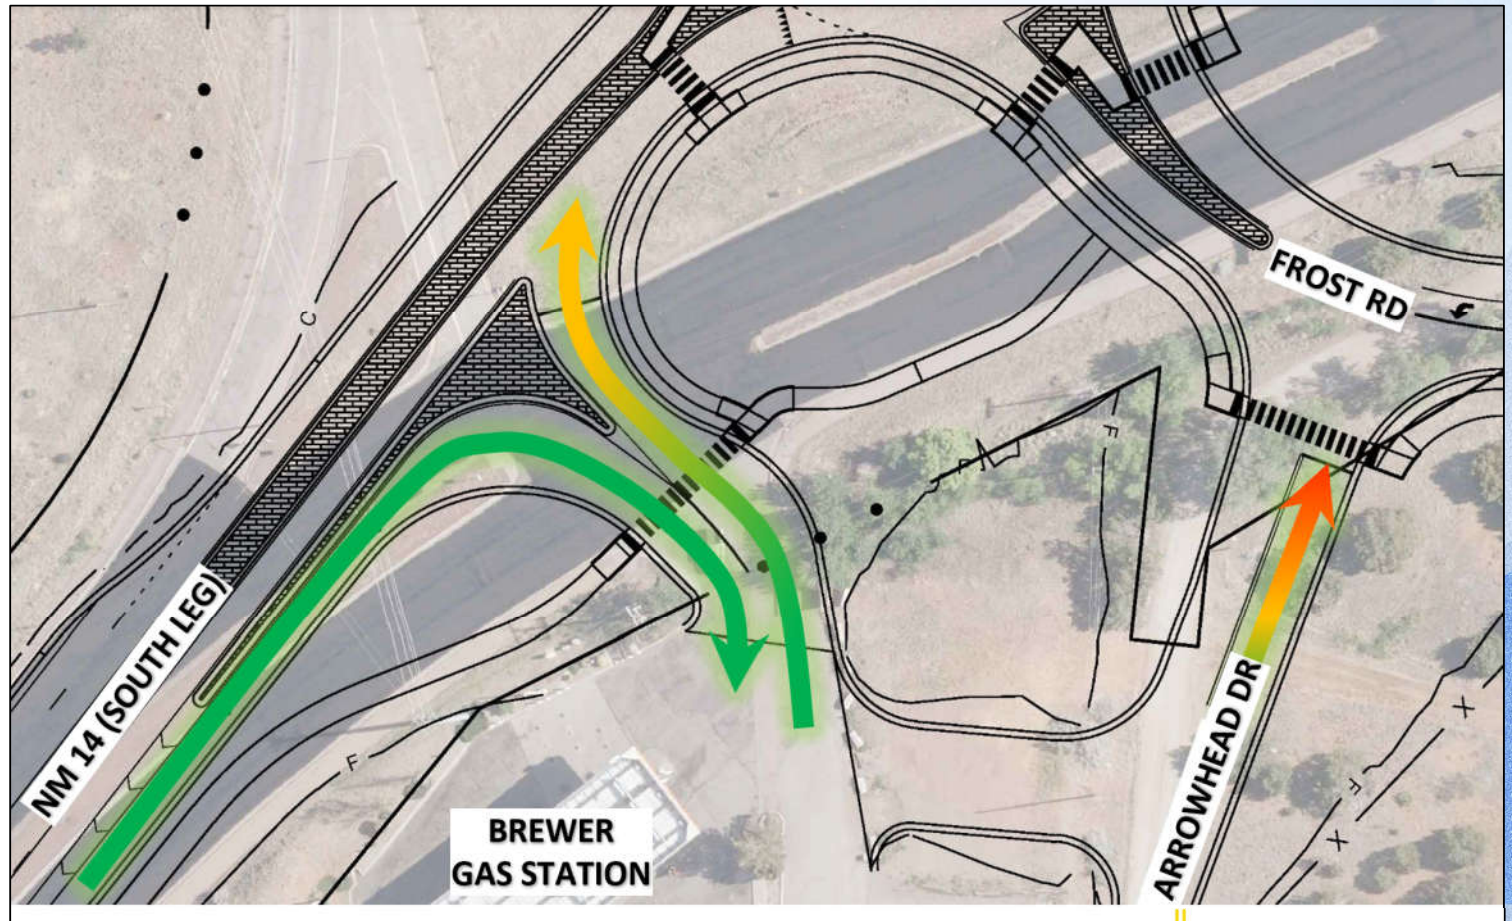
Business Access

- Existing access will become a “right-in/right-out” along NM 14
- New full access from Arrowhead Drive

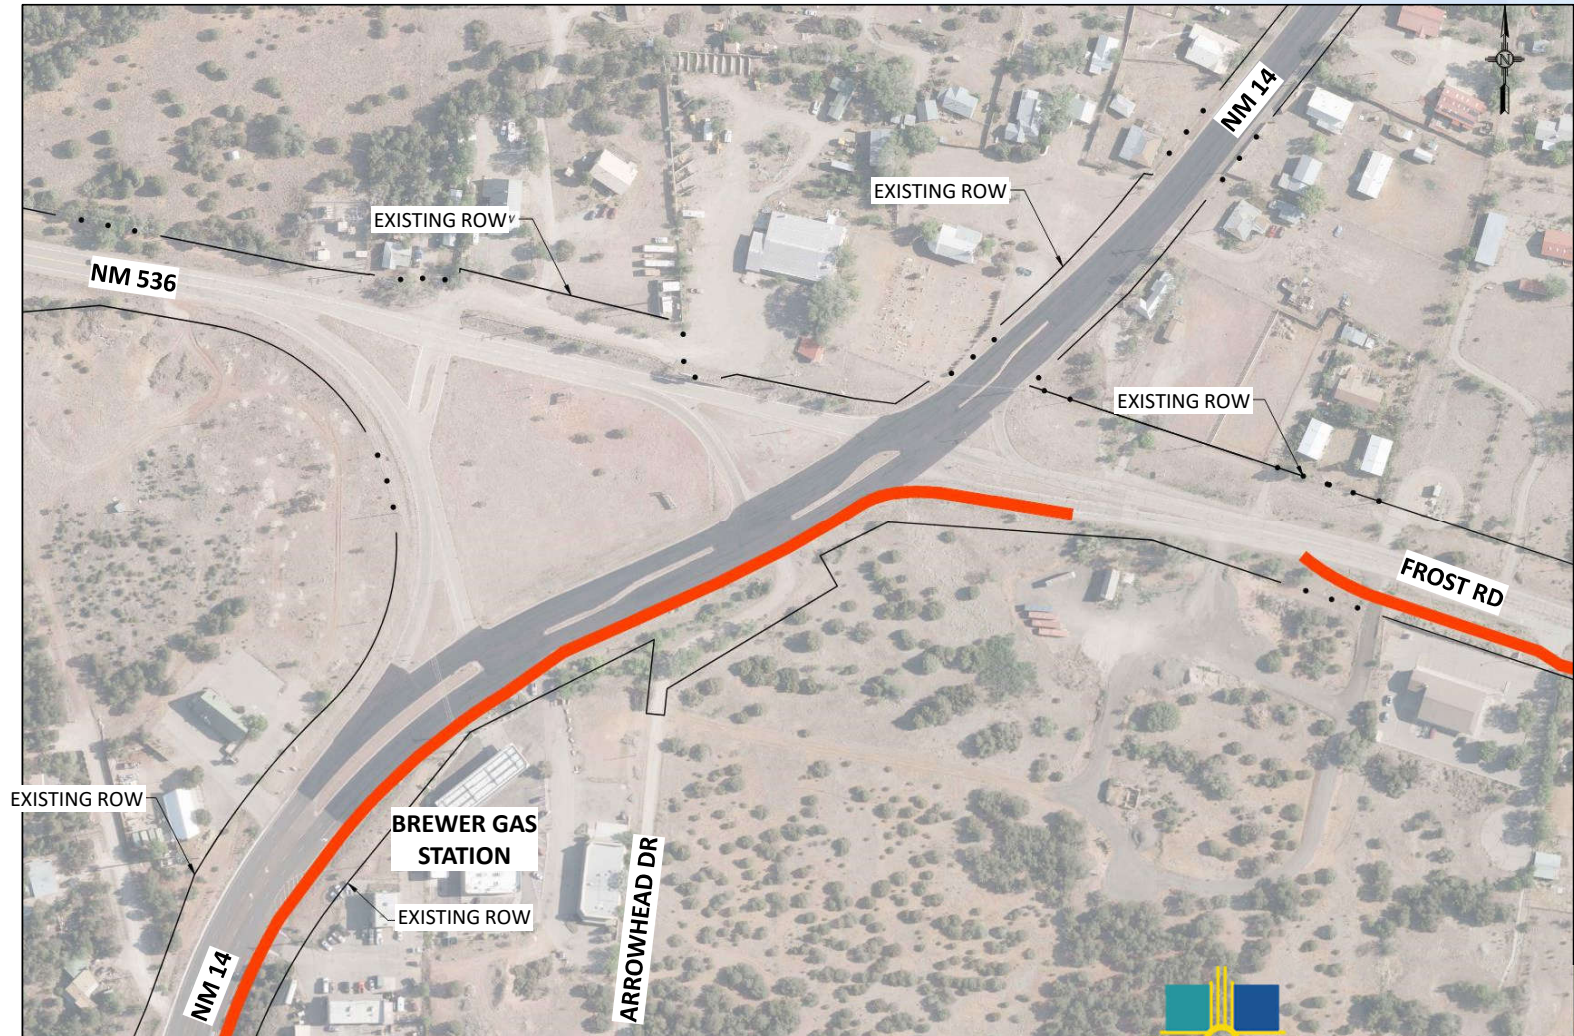
Existing Pedestrian Access

- Multi-Use Path along east side of NM 14 ends at Frost Rd
- 300' gap (no path)
- Multi-Use Path picks up again on Frost Rd and continues east

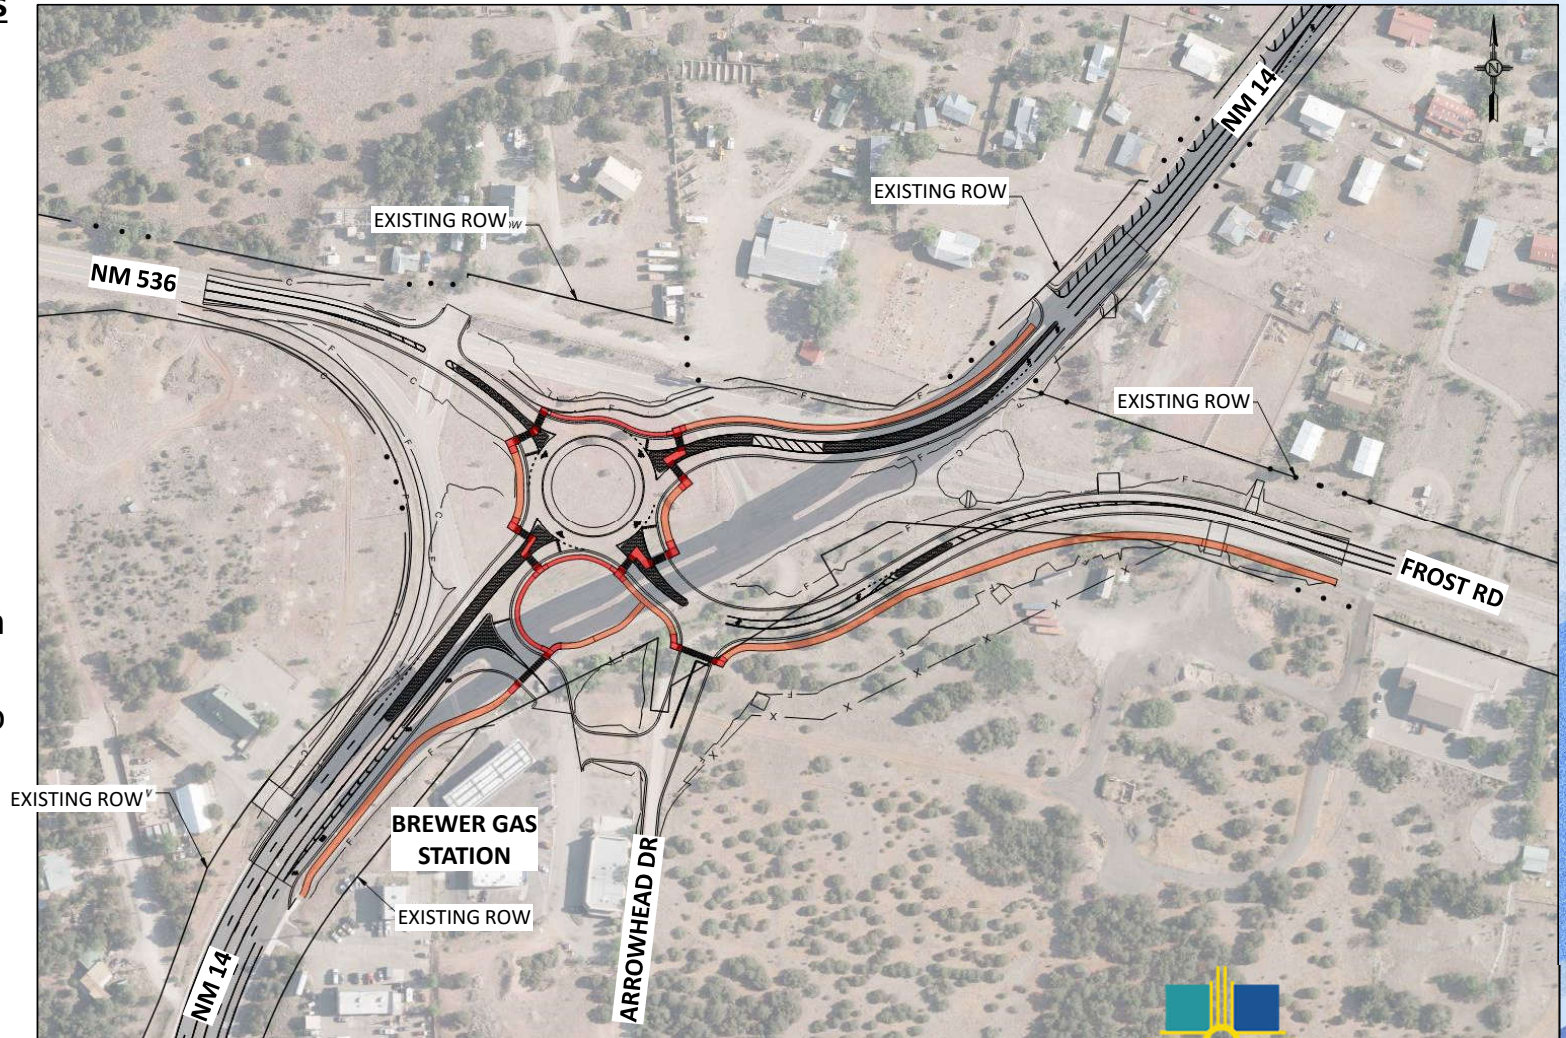
Proposed Pedestrian Access

- New Multi-Use Path will close gap at Frost Rd
- Pedestrians will have full access throughout the intersection
- New Multi-Use Path connection up to San Antonito Church
- Future connection to San Antonito Elementary School through Bernalillo County Public Works Project
- Bicyclists can utilize new Sidewalk/Multi-Use Path system or share the road

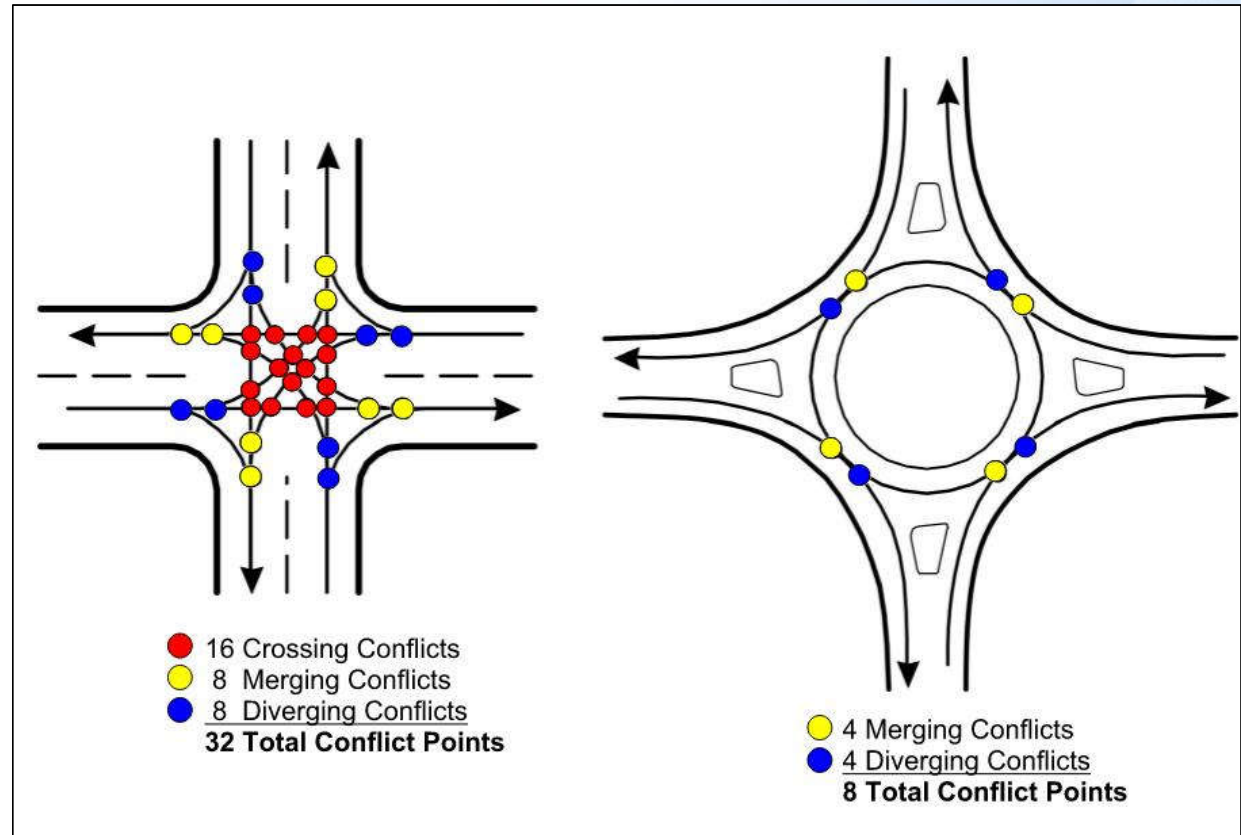
Vehicle Conflict Points

Comparison of Traditional Intersection vs. Roundabout with single-lane approaches

- Diverging Conflicts:
 - Caused by the separation of two traffic streams
 - Higher speed differentials increase risk of rear-end collision (low severity)
- Merging Conflicts:
 - Caused by the joining of two traffic streams
 - Higher possibility of collision to the side of the vehicle (medium severity)
- Crossing Conflicts:
 - Occur where the path of two streams intersect
 - High risk of right-angle crashes and head-on crashes (most severe)
