NM 14/NM 536/Frost Rd Intersection Reconstruction CN A301442

TransCon 2023

AGENDA

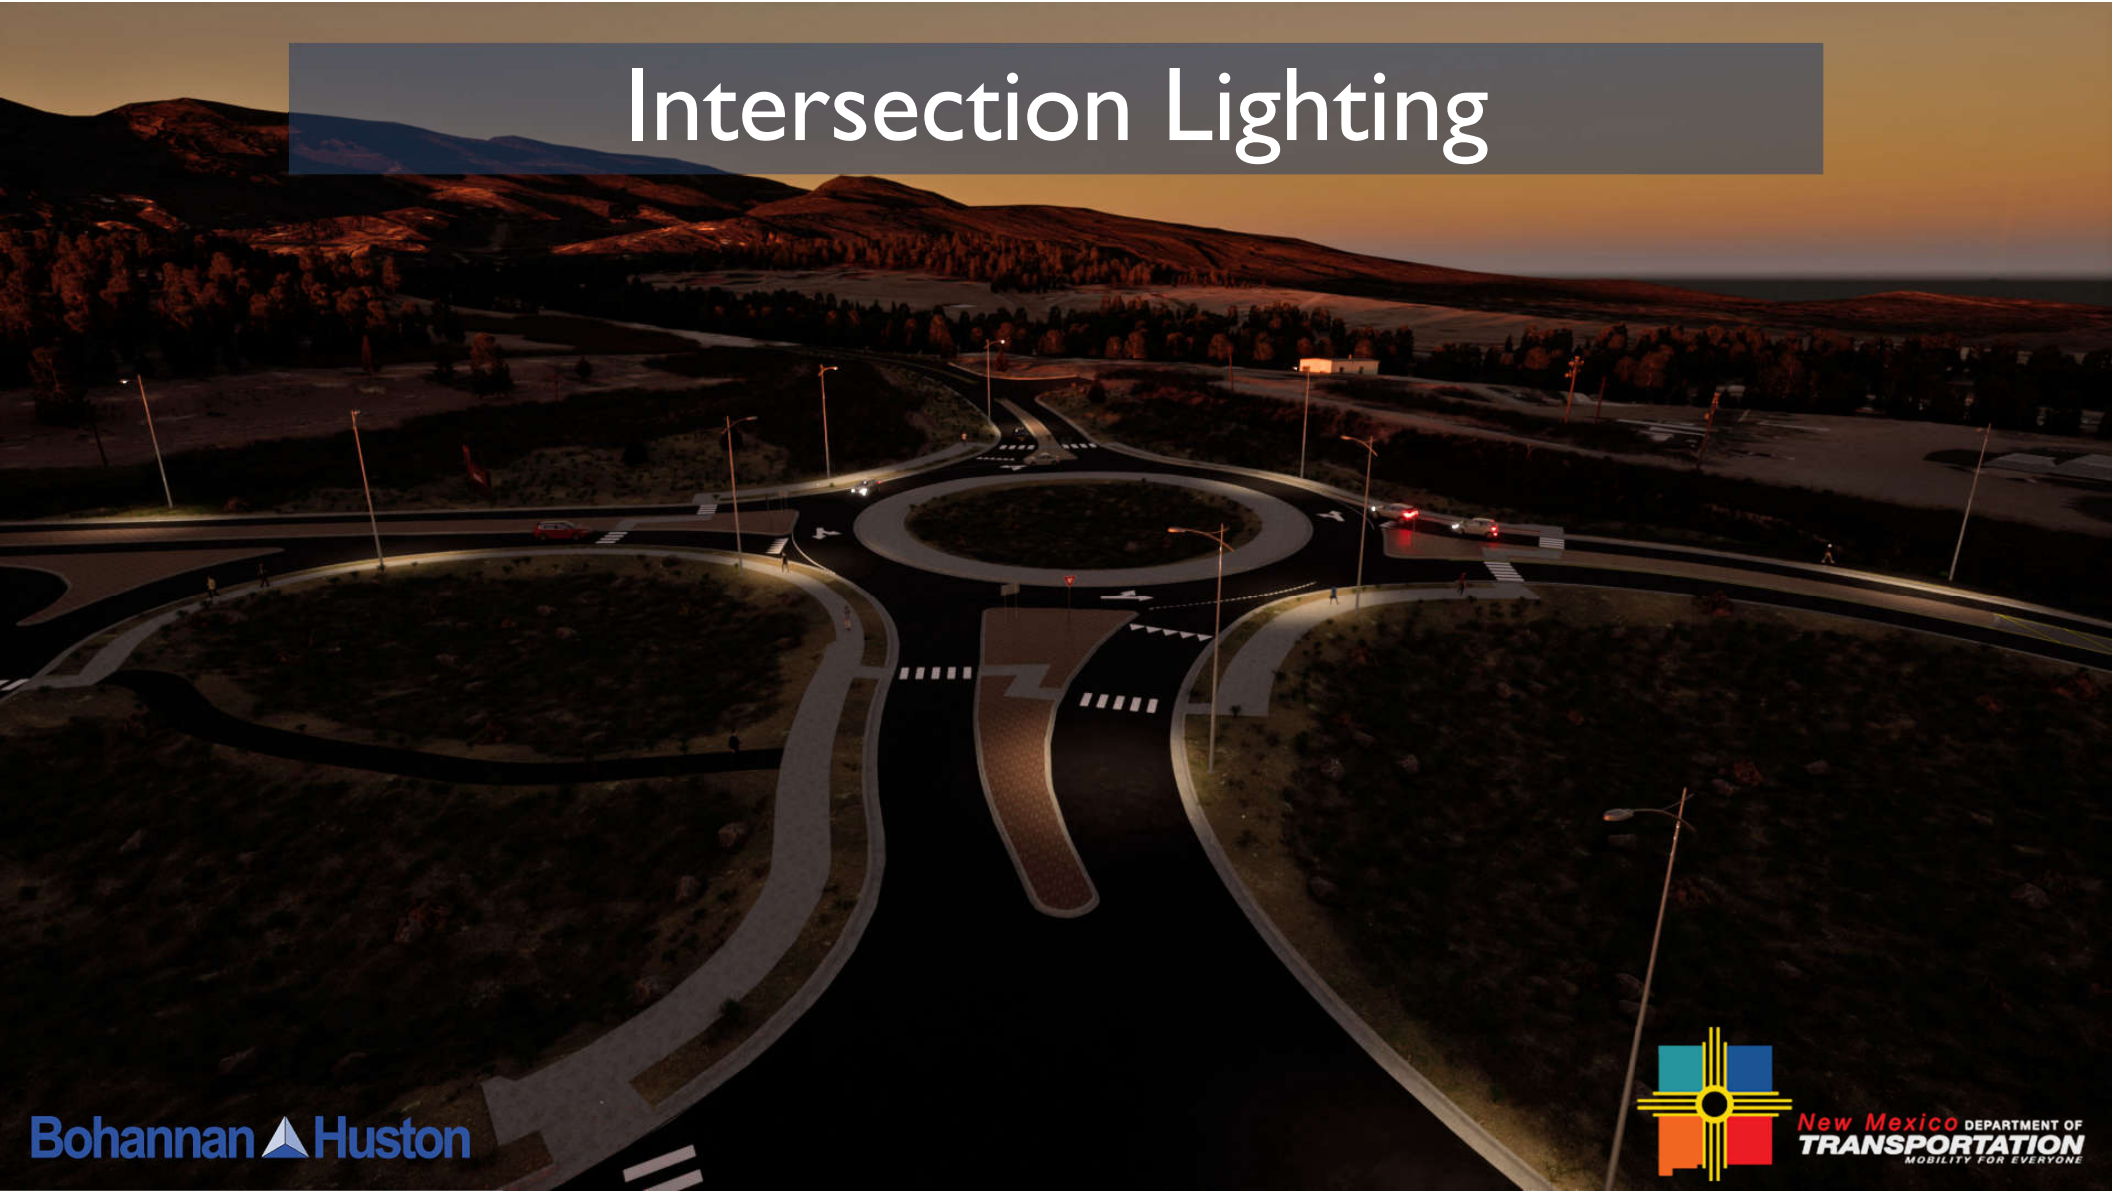
Intersection Lighting

- New 30' light poles will be installed
- Compliant with New Mexico Night Sky Protection Act

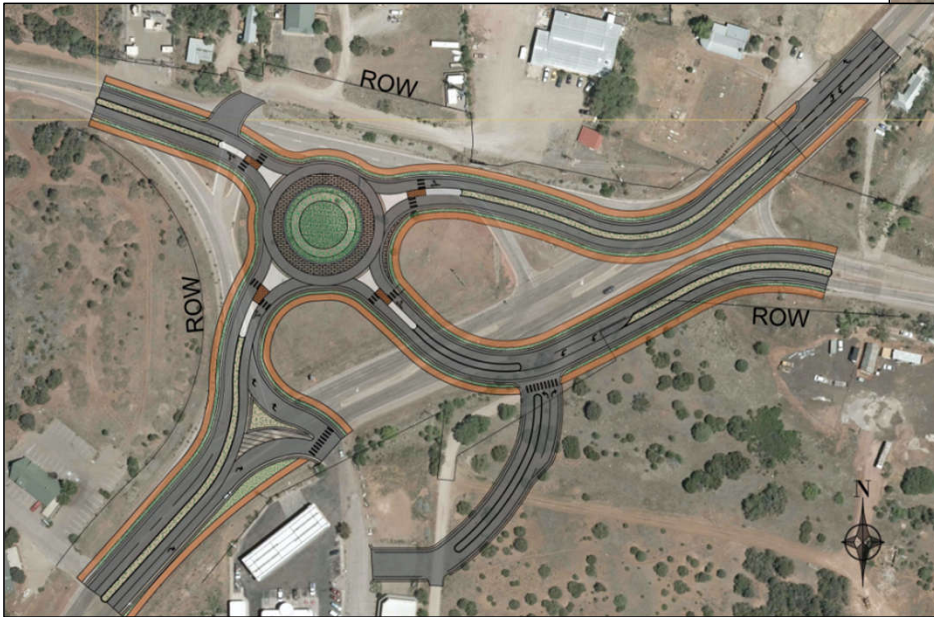
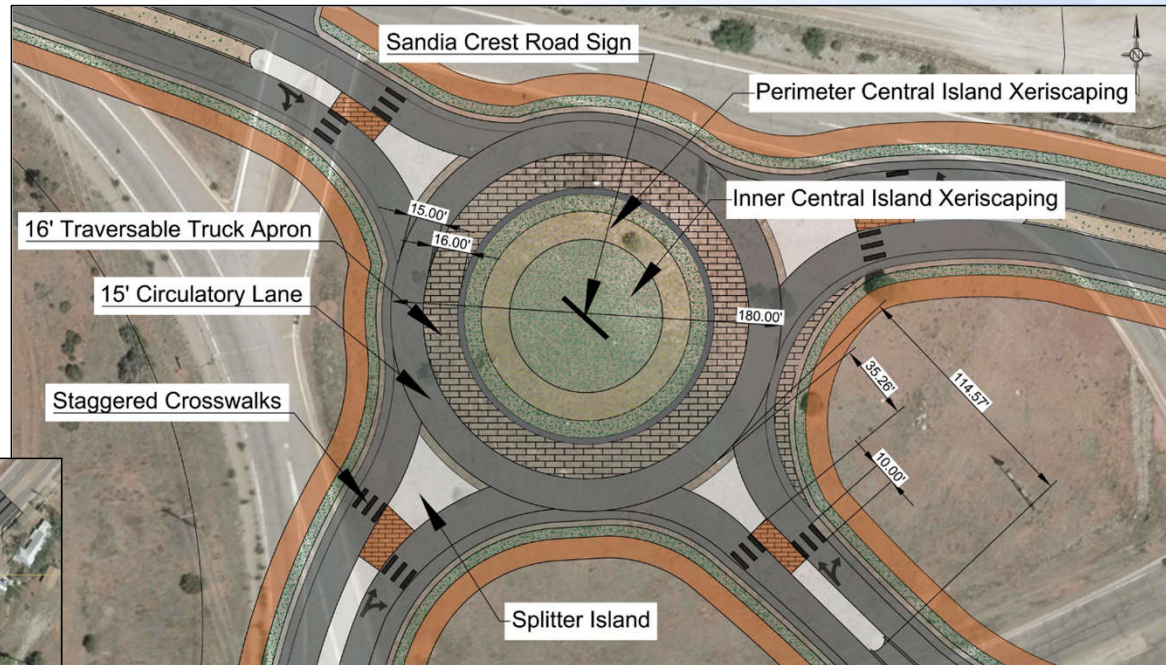
UNM Capstone

- Mentored a team of Graduating seniors during the Fall 2022 semester.
- Assisted them taking this project through a “Study” Phase and into preliminary Design.

Radius	Radius (ft)	Speed (MPH)
R1	85.16	19.14
R2	114.11	19.72
R3	100.93	20.44
R4	80.17	17.32
R5	156.58	24.22
